Field Report for Airborne Data Collected In Support of US EPA Region 6 Intercontinental Terminals Company LLC Fire 28 March 2019

Data Results Flight 15, 28 March 2019

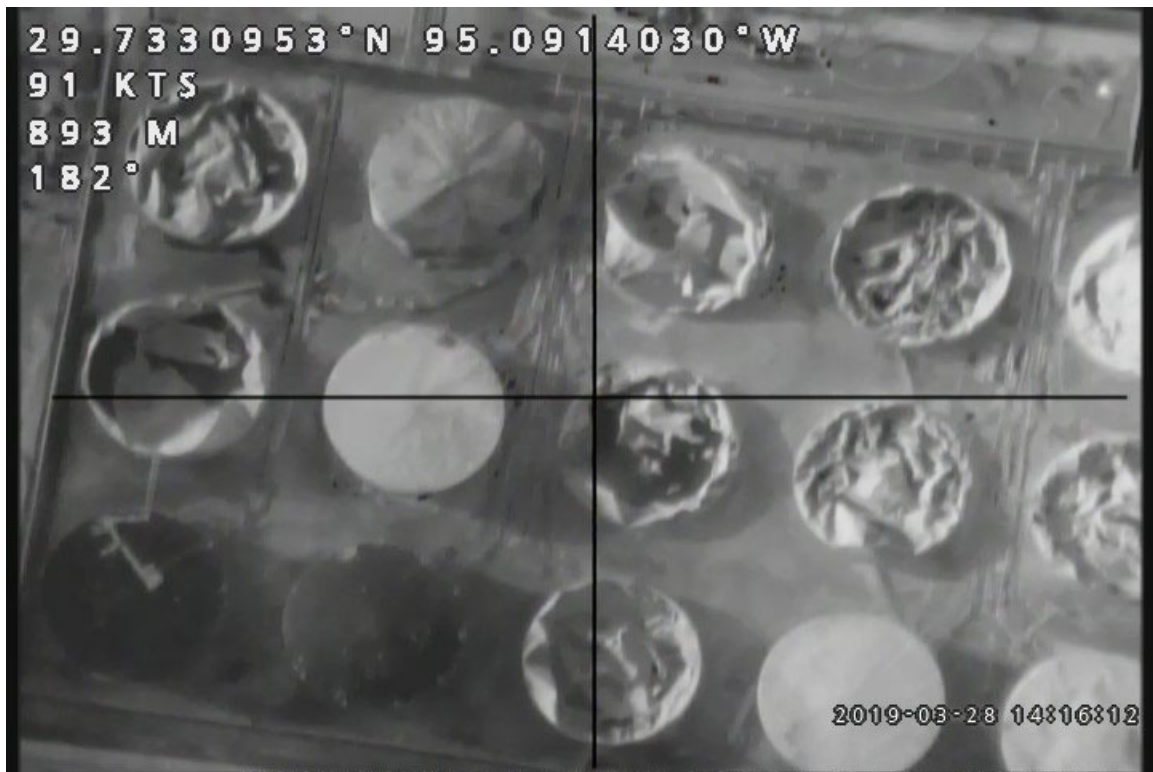
from previous missions again indicating that tank surfaces are at or near ambient temperature (some solar heating is occurring). As with other thermal images, note that the bottom right in the image is the NW due to the image being inverted.

Figure 4: IR Thermal Analysis 28 March 2019, Flight 15, Run 6

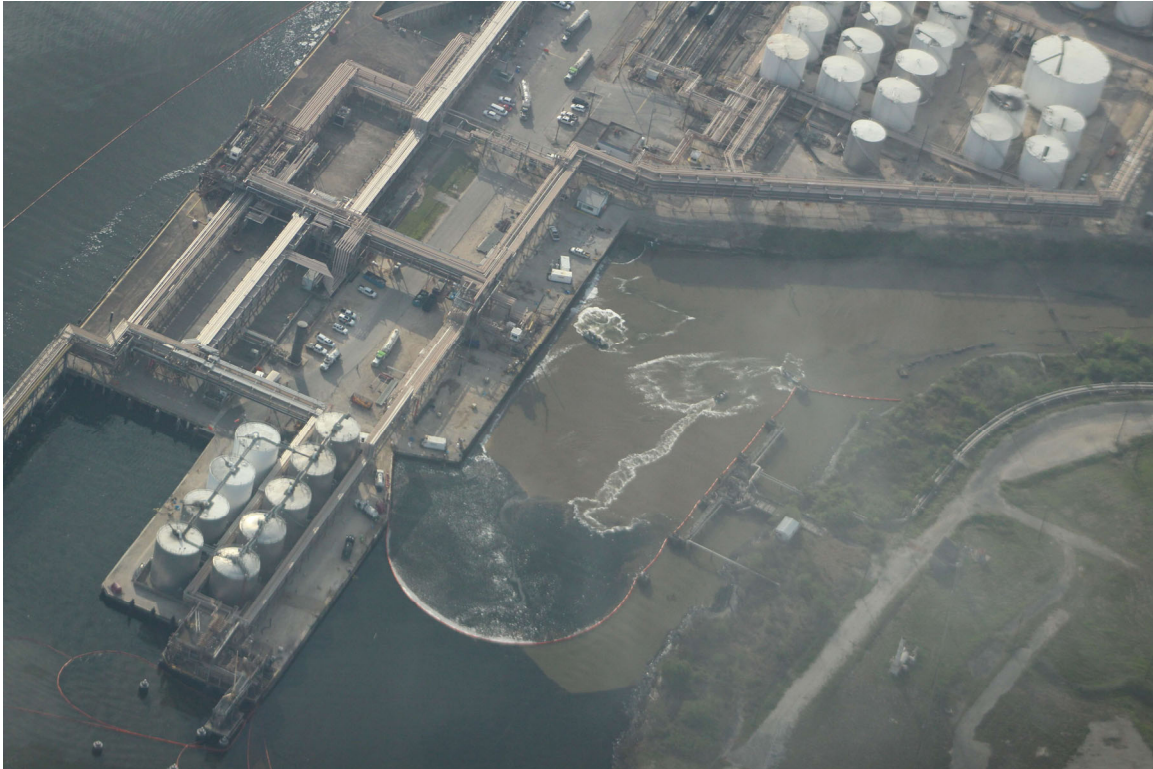
primarily present at the upstream boom and no boom leakage is evident. An oblique of the same area confirms the presence of trapped material in the upstream boom (Figure 8). The white signature present on the overhead and IR is actually boat wakes. Product containment appears to be solid in the oblique.

Figure 8: Oblique Image of the Ship Channel Boom Area, 28 March 2019, Flight 15
